INVESTIGATION REPORT

GROSVENOR MINE

Incident Title: CH₄ Exceedance LW103

Incident Date: 7 November 2019

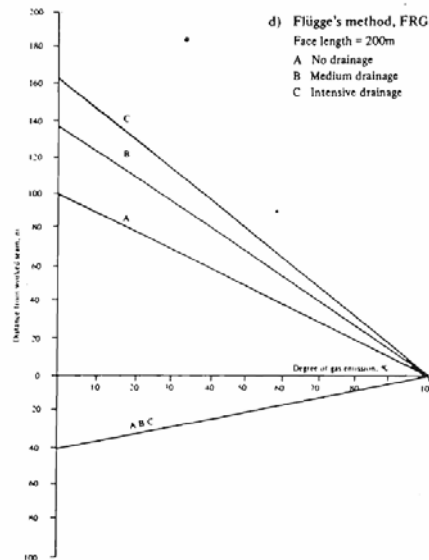
Figure 1 - Flugge Model for Predicting Gas Emission Degrees

This model suggests that the deepest below the floor that a seam may emit emissions from is 40m. This is in a similar range to the value derived from the empirical model by Bai & Tu for estimating floor fracturing creating a hydraulic conduit for gas to flow from underlying seams. As such it can be concluded that seams up to 40m below the seam floor should be considered for potential to emit gas into the LW working area/goaf. In the zone for this LFI, this would include the GML and the Harrow Creek Lower Measures (see Appendix: Stratigraphy).

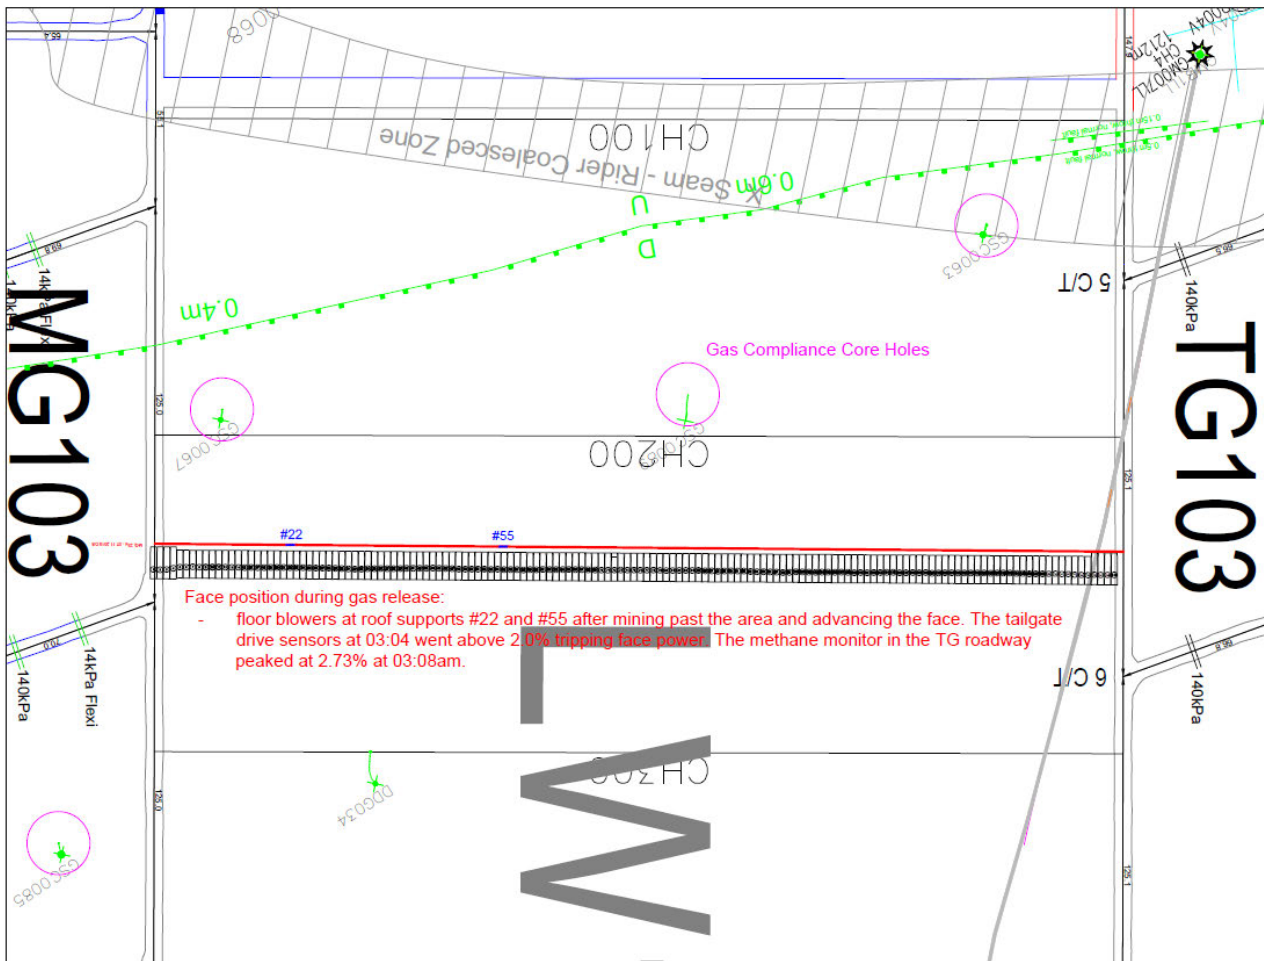
Figure 2 – Geological Conditions During Event

This section shows that the face was not affected by any geological discontinuities at the time of the event, with the only major structure within the area located approximately 80m outbye in the maingate at the time of the event. This information suggests the this event was not caused by a localized geological structure.

In addition to this, the diagram above also shows gas compliance holes within the area of the event, however none of these holes took samples of the underlying seams below the GM.

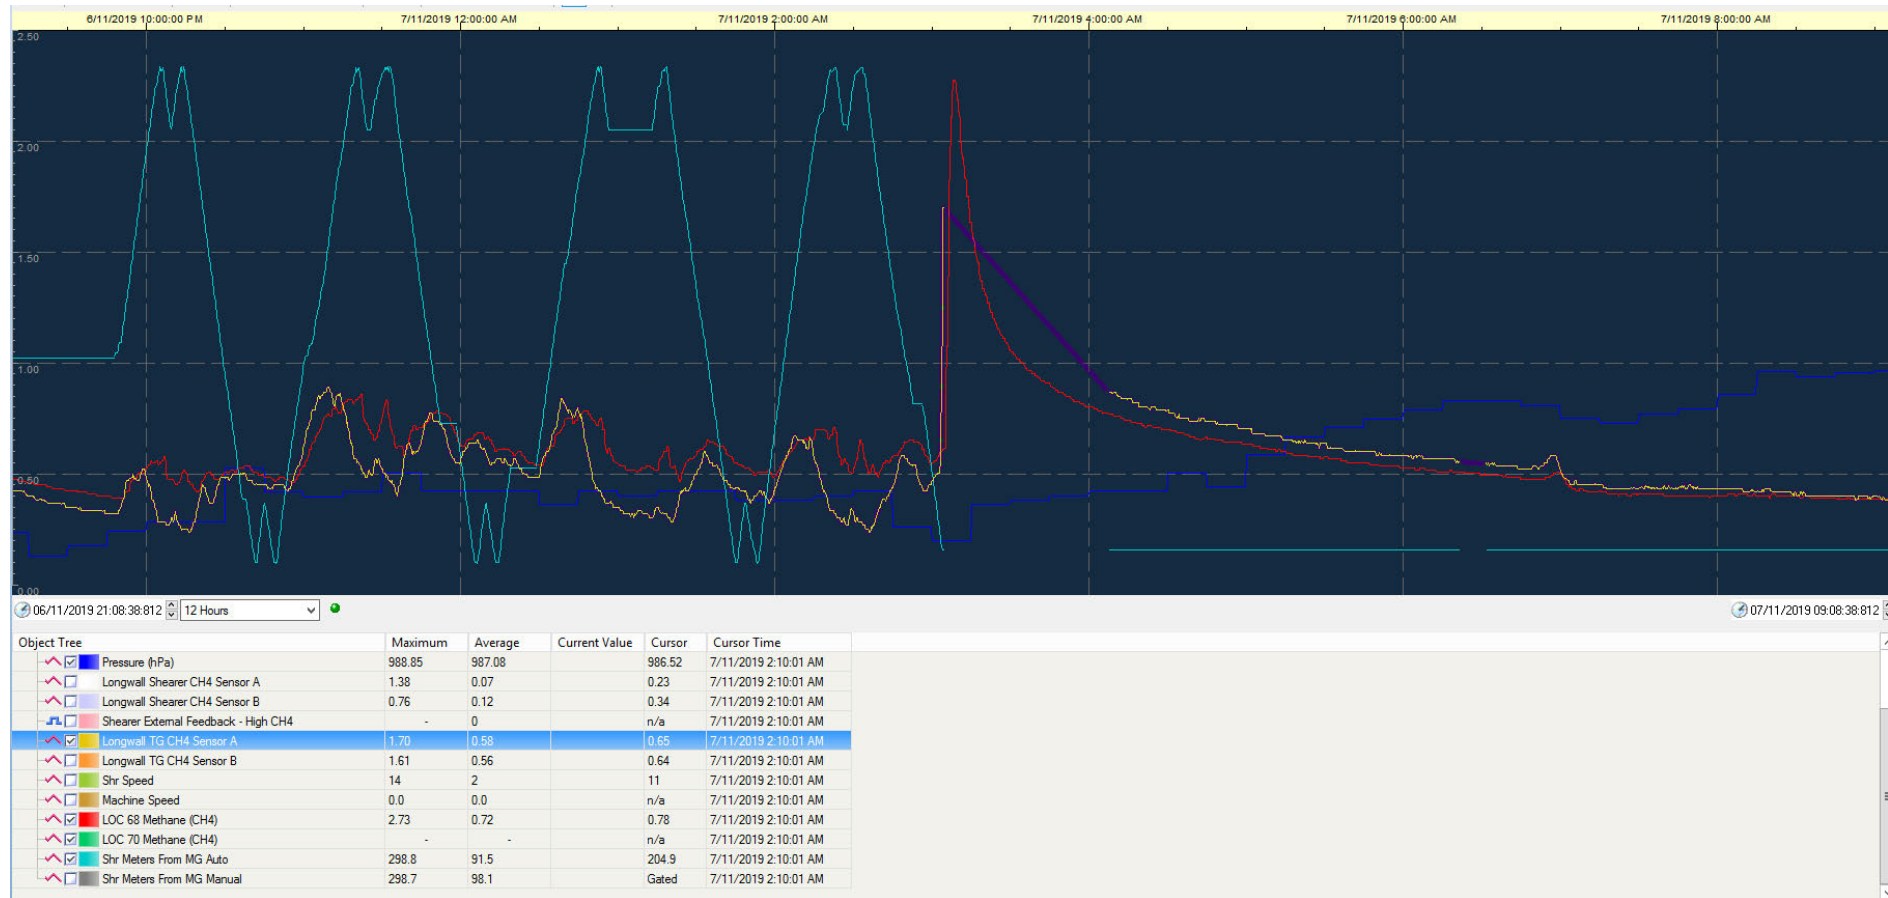
15 APPENDIX: EVENT CITECT TREND

On Thursday the 7th of November during normal production, the shearer on the LW103 face was travelling to the MG (cutting bi-directional) when at roof support #9, a floor blower became active at roof supports #22 and #55 after mining past the area and advancing the face. The tailgate drive sensors at 03:04 went above 2.0% tripping face power. The methane monitor in the TG roadway peaked at 2.73% at 03:08am.

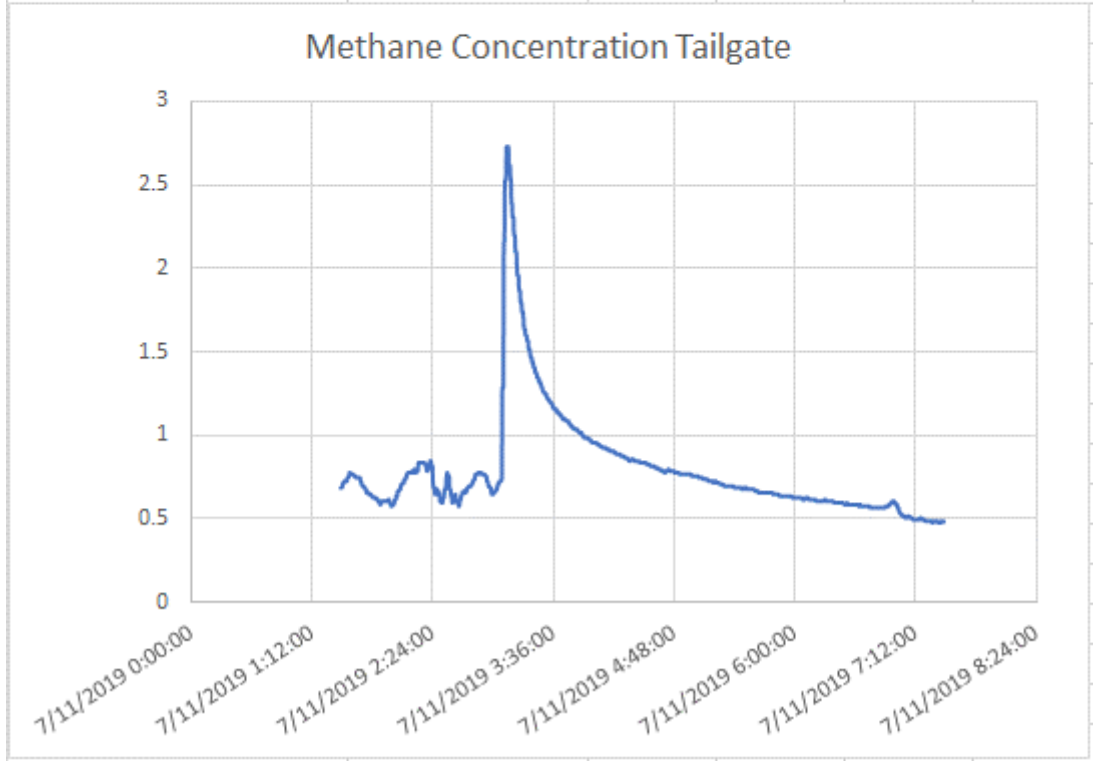
16 APPENDIX: GAS MAKE CALCULATION

The methane calculated to have released into the mine's general body atmosphere was approximately 1,504m³ after 2 hours before returning to normal background levels.

Baseline CH4 before event	0.73				
Tailgate CH4					
Start of Event	7/11/2019 3:04				
End of Event	7/11/2019 5:08				
Peak CH4 through fan (%)	2.73				
Total CH4 Released (m3)	1,504
