RE: HPI 0 meter

METALLURGICAL COAL
GRASSTREE MINE
Private Mail Bag, Middlemount, Qld, 4746
www.angloamerican.com.au
A member of the Anglo American plc group

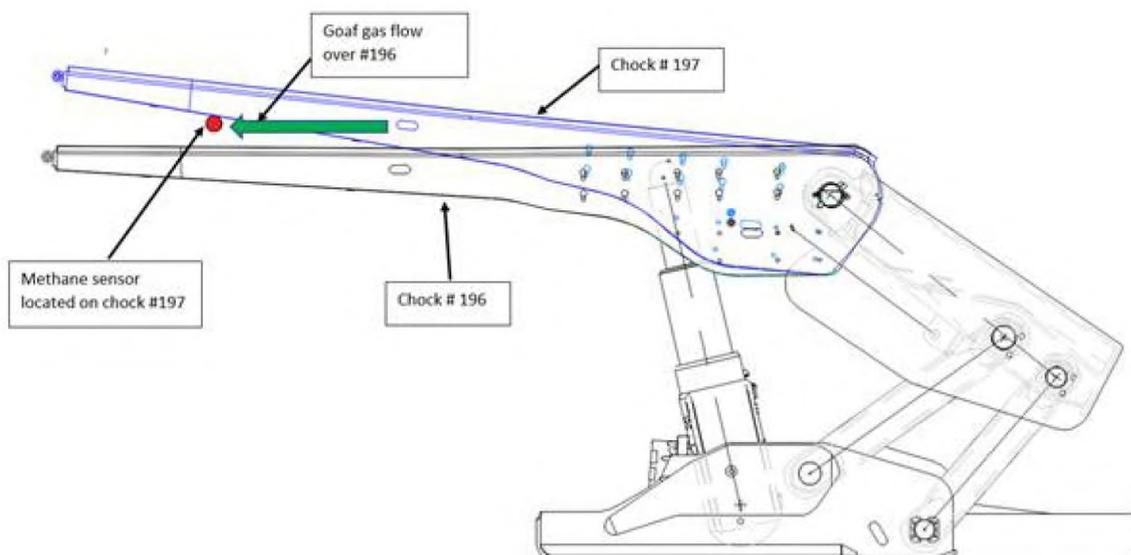
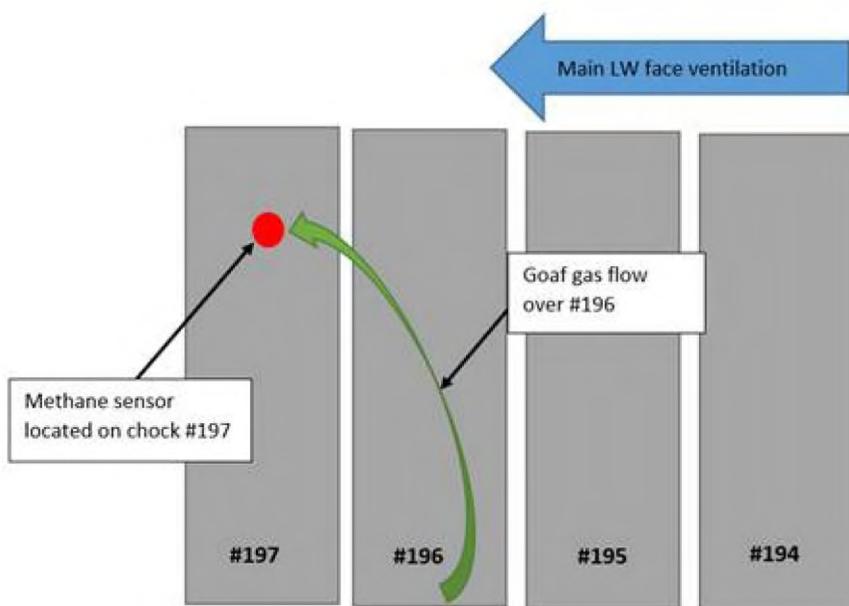
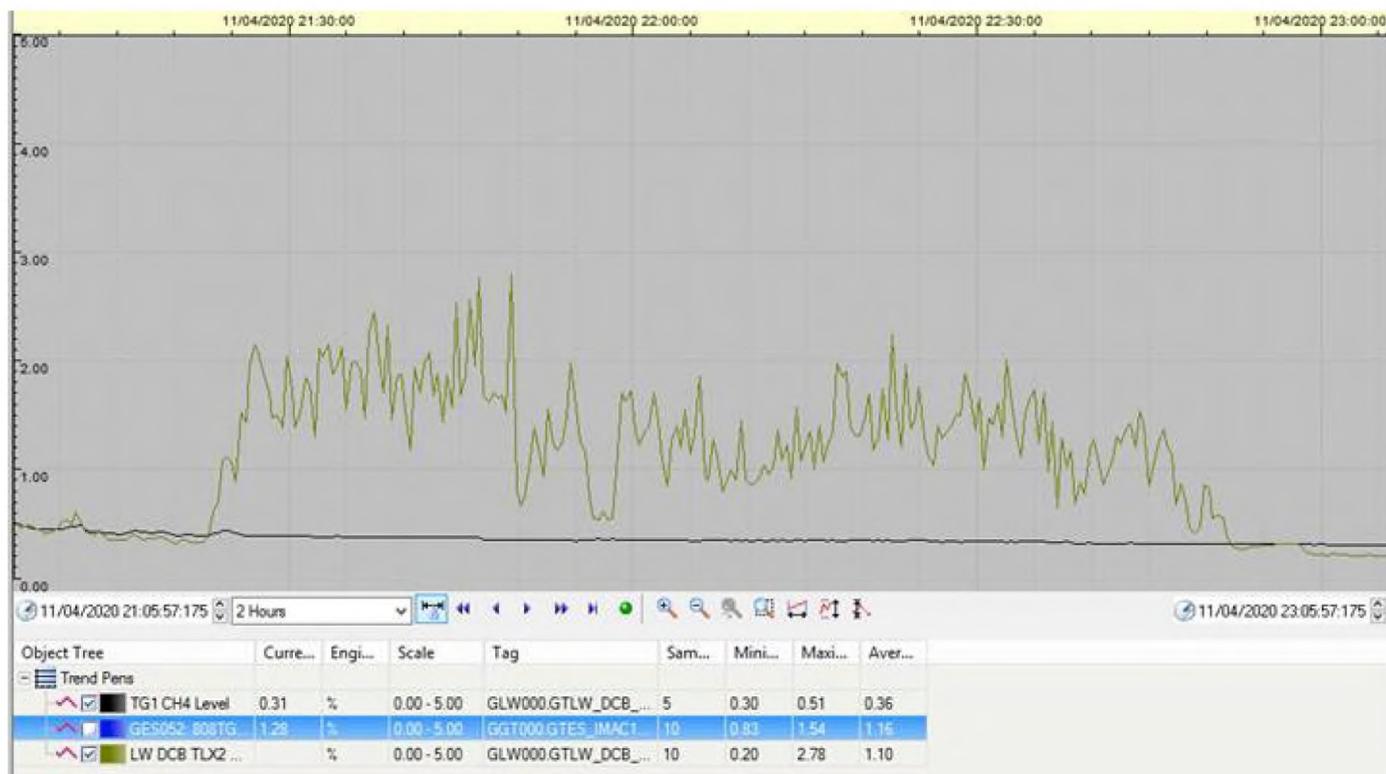
- * Chock #197 was set approx. 300mm higher than #196 as development take additional roof when cutting intersections and the LW cutting parameter is constantly set at 2.1m (this can also occur at other times when the LW is not passing through intersections such as cavities in the TG roadway or tilting of the chock)
- * When this gap occurs it allows goaf gas to pass over the top of #196 and flows straight into the sensor located on #197, as shown in the diagrams below
- * This means in this situation the sensor located on chock #197 is not reading general body, it is reading the layering of gas that flows over #196 (See trending below #197 sensor Vs TG drive sensor)

This evening at 21:25:56 the 0 meter sensor reached >2% and at 21:25:59 reached >2.5% CH4. The goaf has come in as we have not long come past 3ct in the TG, there is a 300mm gap between 196 and 196 chock and the goaf was passing through over the sensor.

As you can see the TG roadway sensor remained at 1.1-1.3 % during the period, it is clearly the goaf stream coming over the sensor.
I have had the Longwall crew put brattice across the TG chocks to stop the goaf stream coming between the chocks and re-instate the Sherwood curtain in the roadway.

- * N/S has already installed a Sherwood Certain
- * Adjusted the flap installed on chock #194 to provide better airflow in towards the back of the chocks
- * Drained the drill niche at 1ct for the HGH

- * I'll review the LW playback once I get the video file from the LW this arvo to check the correct chock advance sequence was followed
- * Consider increasing cutting profile when entering the TG to suit the roadway height to reduce the magnitude of the gap between #196 and #197 (may need to change this from #190 to stagger the change in height)
