Mine Name	MineID	Operator	Activity Type	Activity Date
Moranbah North	MI00750	Anglo Coal (Moranbah North Management) Pty Ltd	Inspection	17/09/2019

Mine Record Entry

Today the 17th September 2019 Department of Natural Resources Mines and Energy inspectors Malcolm Brownnett and Keith Brennan travelled to Moranbah North underground operations to investigate the recent high number of gas exceedances and rib failures including a general inspection.

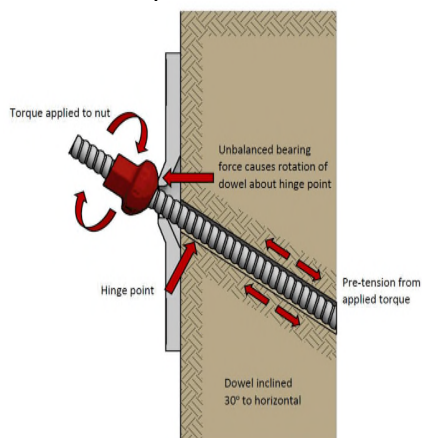
- Trial and implementation of an Extra High Torque (XHT) fibreglass dowel with shank torque strength of >290 N.m. provided to resist over tensioning during installation and a rod shear strength of >60 kN. XHT bolts are grey to differentiate between the HT (white) fibreglass bolts.
- 1200mm spin to stall resins were trialled and implemented to improve encapsulation, in addition to this larger limestone grit particles were added to assist in shredding the capsule and improvement in bond strength of the resin to bolt/coal.
- An amendment to the provided plastic steel combination plate increased the hole aperture to 42mm (from 36mm) to allow bending of bolt at collar upon installation at various angles. The 42mm aperture retained the desired 5t pull-through load.

The position of the lower rib bolt has been restricted between 1.4m - 1.6m height i.e. above Tonstein band – to reduce the bolt angle and provide a better quality of installation.

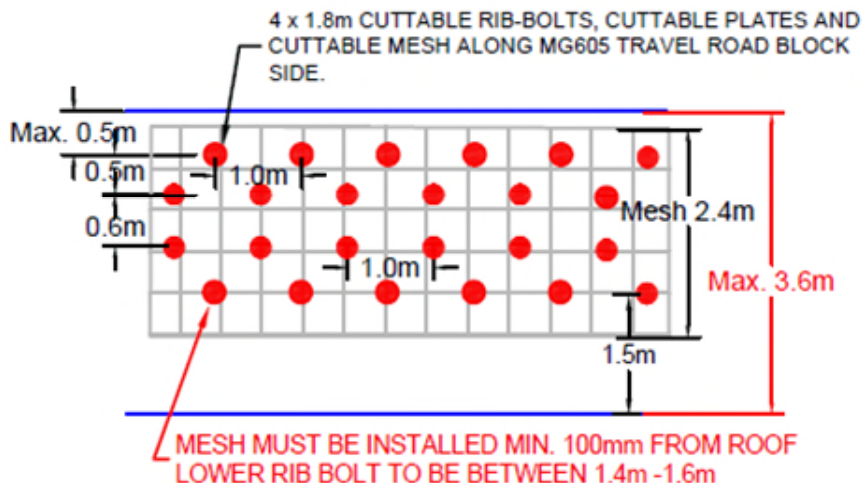
TRAVEL ROAD BLOCK SIDE CUTTABLE RIB BOLT PLAN

Initial 4 x 1.8m fibreglass rib bolts/1.0m pattern

ADHERE TO SCARP SPOT BOLTING GUIDE TO CONTROL RIB DEFORMATION.

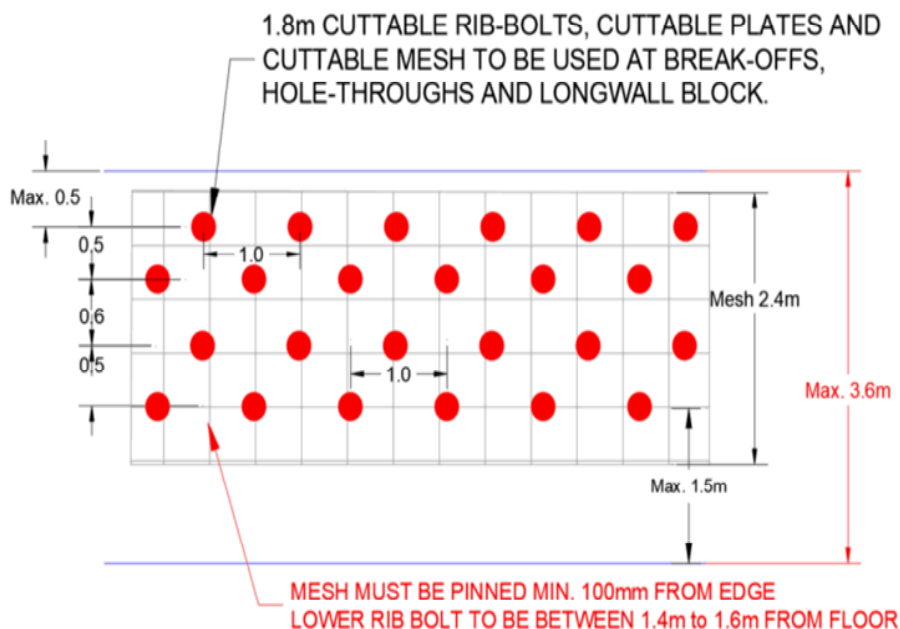
CUTTABLE RIB BOLT PLAN

Revised 4 x 1.8m fibreglass rib bolts/1.0m pattern

ADHERE TO SCARP SPOT BOLTING GUIDE TO CONTROL RIB DEFORMATION.

Additional rib remedial equipment to site will include another shotcreting rig, loader and crews to man the additional rig brought to site. The additional rig will allow one shotcrete rig to focus on development block side shotcrete. The second shotcrete rig will focus on remediating strata defects located in outbye areas. Shotcrete has been proven to assist in confinement of the rib and protection of installed support from machinery interaction and abutment loads.
